# Study of Ideal Dry Pipe Valve

A STUDY  
of  
IDEAL DRY PIPE VALVE

A T H E S I S

BACHELOR OF SCIENCE IN FIRE PROTECTION ENGINEERING

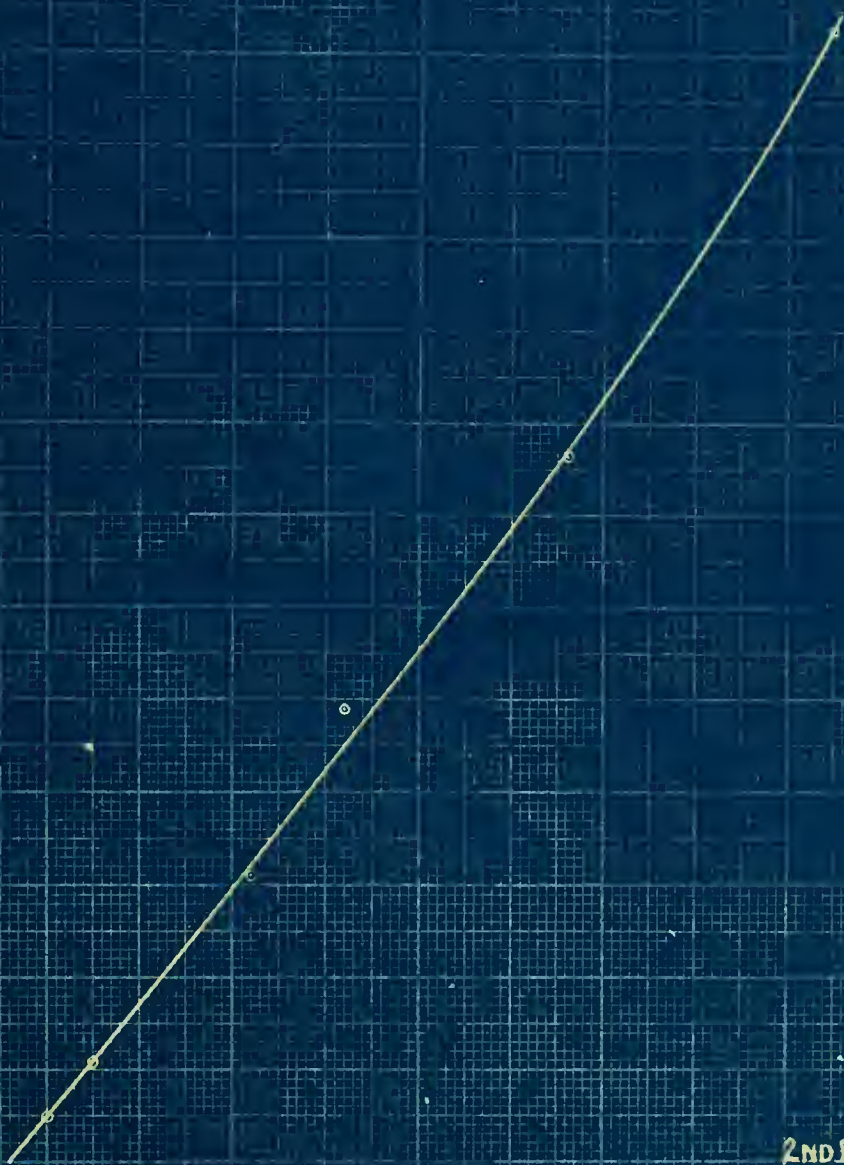
2ND PATTERN

With this size by-pass it was not possible to obtain any water hammer, but a violent fluctuation of the mercury gauge and peculiar sounds in the valve when it "fired" would indicate that there was some movement of the movable member. Apparently, we have reached a size of by-pass which is nearly large enough to safely carry the flow from the lower chamber to the upper chamber.
